ASSESSING MATERIAL PERFORMANCE IN CHLORINATED POTABLE WATER APPLICATIONS

P. Vibien, J. Couch and K. Oliphant
Jana Laboratories Inc., Aurora, Ontario, Canada

W. Zhou, B. Zhang and A. Chudnovsky
Fracture Mechanics & Materials Durability Laboratory, CME Department,
UIC, Chicago, IL, USA

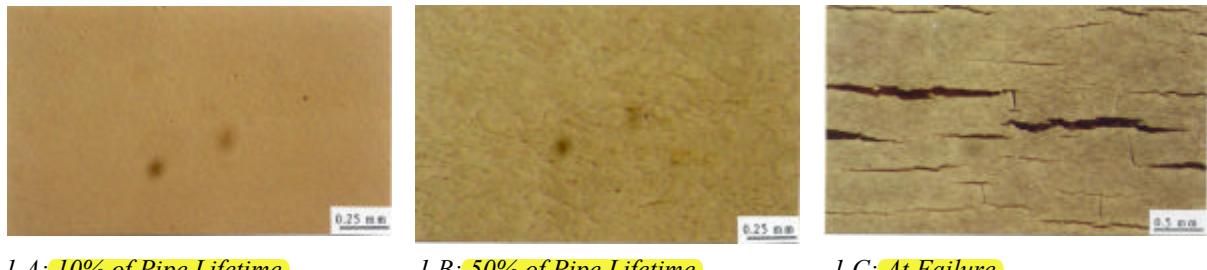
Figure 1 shows the inner exposed surface of the PEX piping material as a function of exposure time. Figure 2 shows the same samples looking through the wall of the exposed pipe specimens (with the inner exposed surface facing the bottom of each picture). At 10% of the lifetime a fine degradation layer has formed on the inner exposed surface as seen in Figures 1A and 2A. At 50% of the lifetime, micro-cracks are visible on the inner exposed surface (Figure 1B). The degradation layer thickness has increased (Figure 2B) and the micro-cracks are starting to propagate radially through the pipe wall. At ultimate failure several very large micro-cracks are visible on the inner exposed surface (Figure 1C) and the degradation layer thickness has increased significantly (Figure 2C). Ultimate failure occurred when one of the micro-cracks propagated through the entire wall thickness resulting in a brittle slit failure approximately 2 mm in length.

Figure 1: Progression of Chlorine Induced Degradation of a PEX Pipe Material:
Inner Pipe Surface

FTIR analysis of the exposed pipe samples was conducted to examine degradation. Samples were taken from the inner exposed wall, the mid wall and the outer wall for the same pipe samples as Figures 1 and 2. These results and reviewed briefly here and will be discussed in detail in a future paper.⁶ Based on the carbonyl peak in the region of 1760 cm⁻¹, it is seen that significant oxidation of the inner exposed pipe surface has occurred at 10% of the test lifetime. No change in oxidation is observed at the mid or outer wall. The chlorine, therefore, appears to have rapidly attacked and oxidized the inner exposed pipe surface. At 50% of the pipe lifetime, increased oxidation is observed at the mid and outer wall. The inner wall still, however, shows a significantly higher level of oxidation. At failure, the mid and outer wall are seen to be further oxidized but still less so than the inner exposed surface.

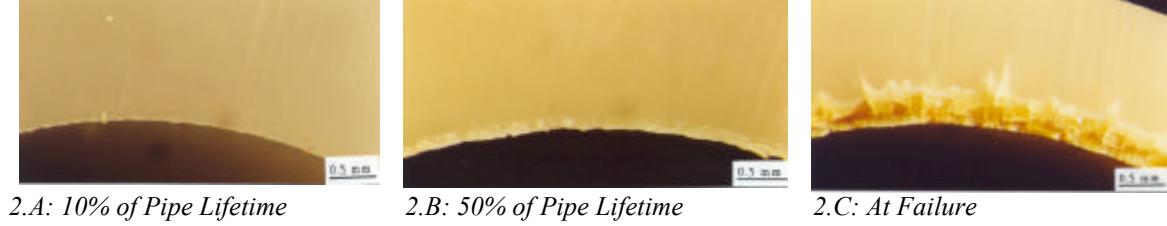
Figure 2: Progression of Chlorine Induced Degradation of a PEX Pipe Material:
Through the Pipe Wall.

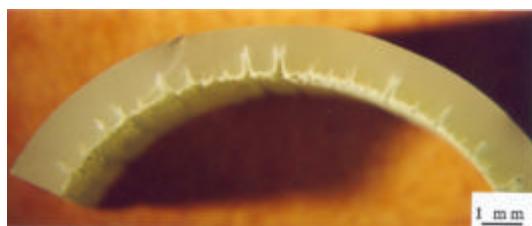
Figure 3: Radial Crack Growth in a PEX Pipe Material.

Figure 3 shows another view of the propagation of the micro-cracks through the pipe wall. Several large cracks are observed, distributed randomly around the circumference of the pipe. In Figure 4, the axial cross section of the same pipe material is shown. The sample was cut along one of the large longitudinal cracks. The advancing crack front is clearly seen in this view. Regions where multiple small cracks have coalesced to form a larger crack are also visible.

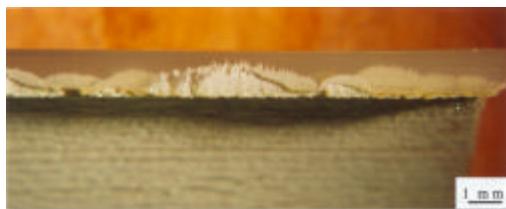
Figure 4: Axial Cross-section of Chlorine Exposed PEX Pipe Material.

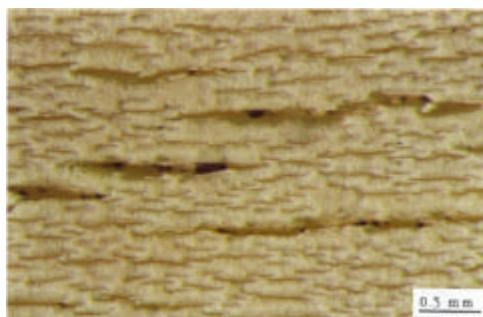
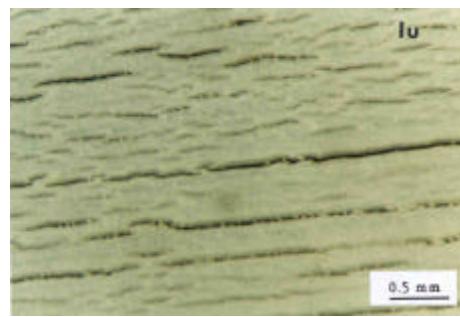
Figure 5 shows the inner exposed pipe surfaces of A: a PEX laboratory failure and B: a PB field failure. The PB field failure was in service for roughly 15 years, exposed to a chlorine level of approximately 1 ppm. Both samples show extensive micro-cracking of the inner exposed surface. The micro-cracks for both materials appear to have coalesced to form larger cracks. Figure 6 shows the same exposed samples looking through the wall. Similar degradation of the inner surface is observed. For both samples the micro-cracks that have initiated on the inner surface are seen to propagate radially through the pipe wall. It is interesting to note what appears to be a higher level of degradation of the PEX material. This may be reflective of the difference in material structure between the PEX and PB materials, or the more aggressive test conditions (higher chlorine level) employed in the laboratory accelerated testing.

Figure 5: Comparison of Observed Failure Mechanism with Field Failures.

5.A: PEX Laboratory Failure

5.B: PB Field Failure

The observed failure mechanism for a PEX laboratory failure and a PB field failure appear to be very similar. The accelerated test methodology employed in this study does, therefore, appear able to replicate potential failure mechanisms in service.

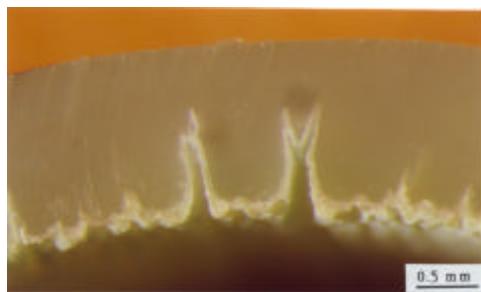
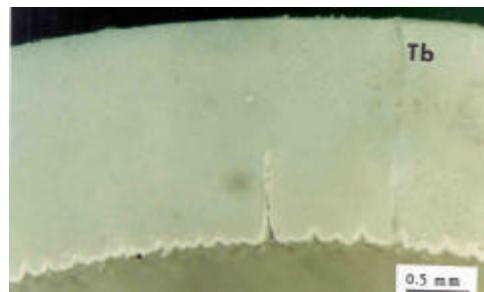
Figure 6: Comparison of Observed Failure Mechanism with Field Failures.

6.A. PEX Laboratory Failure

6.B. PB Field Failure

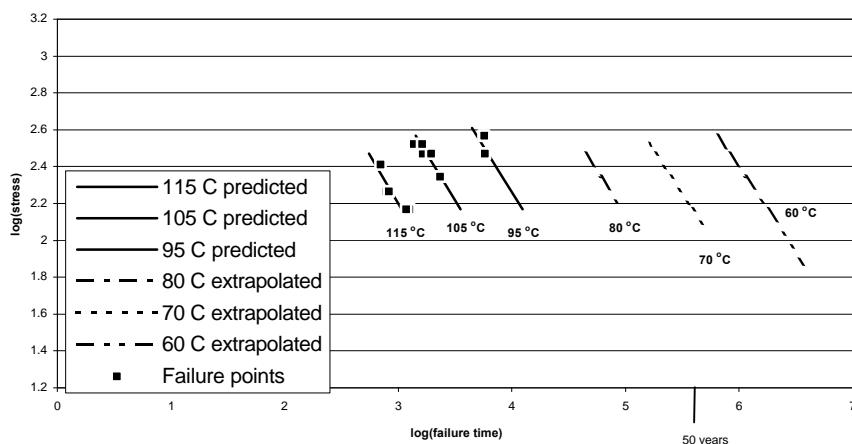
Figure 7: Log(Stress) versus Log(Failure Time) for a PEX Pipe Material

Figure 7 shows a plot of the experimental failure points and the predicted failure times from the Rate Process Model. From the data it is seen that the Rate Process Model provides a good fit to the experimental data. The R^2 for the regression was 0.98. Also shown in Figure 7 are the extrapolated test lifetimes at lower temperatures.

This approach was applied to a commercial PEX pipe material, intended for both hot and cold potable water applications. Testing was conducted at eight different temperature and pressure conditions with a total of 16 failure points generated. The test conditions and failure times are presented in Table 2.

$$\text{Log (failure time)} = -16.45 + 8367.2/T - 372.2/T \cdot \log(\text{hoop stress}) \quad (2)$$
